DIAGNOSTICS & TREATMENT

of Oral and Maxillofacial Pathology

Detection of Titanium Particles in Soft Tissues Adjacent to the Fixators in Patients With Facial Fractures and Bone Defects*

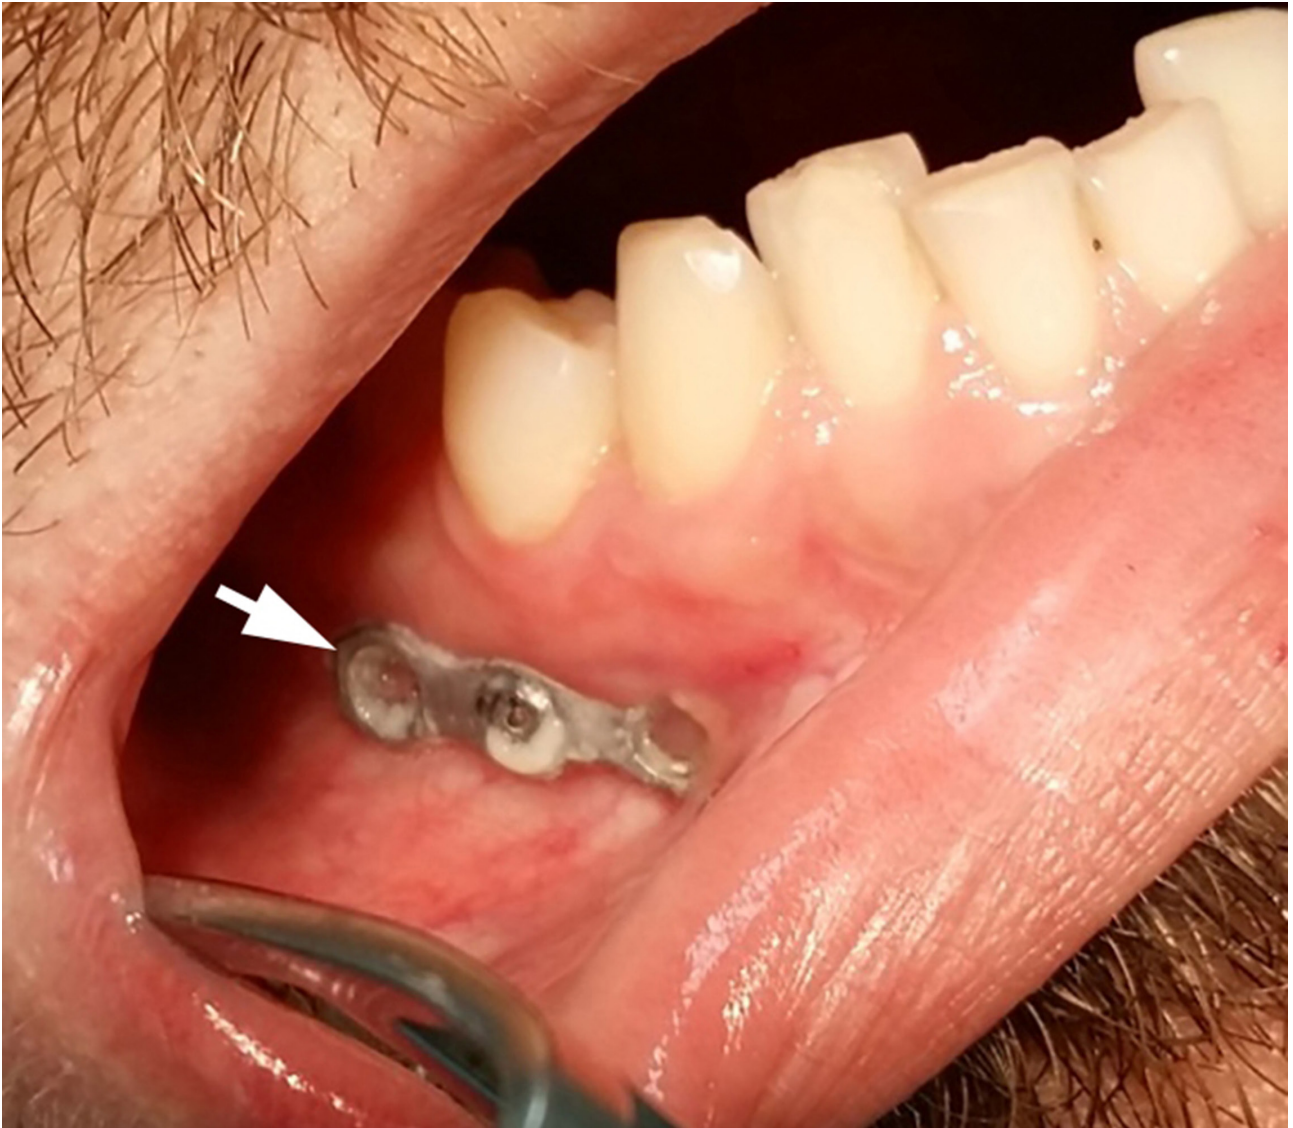
FIGURE 1. A 11.5-month follow-up photograph after mandibular fracture shows exposure of titanium miniplate (*arrow*) in the oral cavity without significant signs of chronic inflammation.

At the removal of the fixation elements, macroscopic signs of chronic inflammation in adjacent soft tissues were noted in 1 (8.3%) patient. Exposure of fixators was noted in 4 (33.3%) patients (Fig 1). Local grey coloring was seen in 8 (66.6%) patients, predominantly in the area of the installed screws. In most observations, the loosening of at least one of the fixing screws was noted.

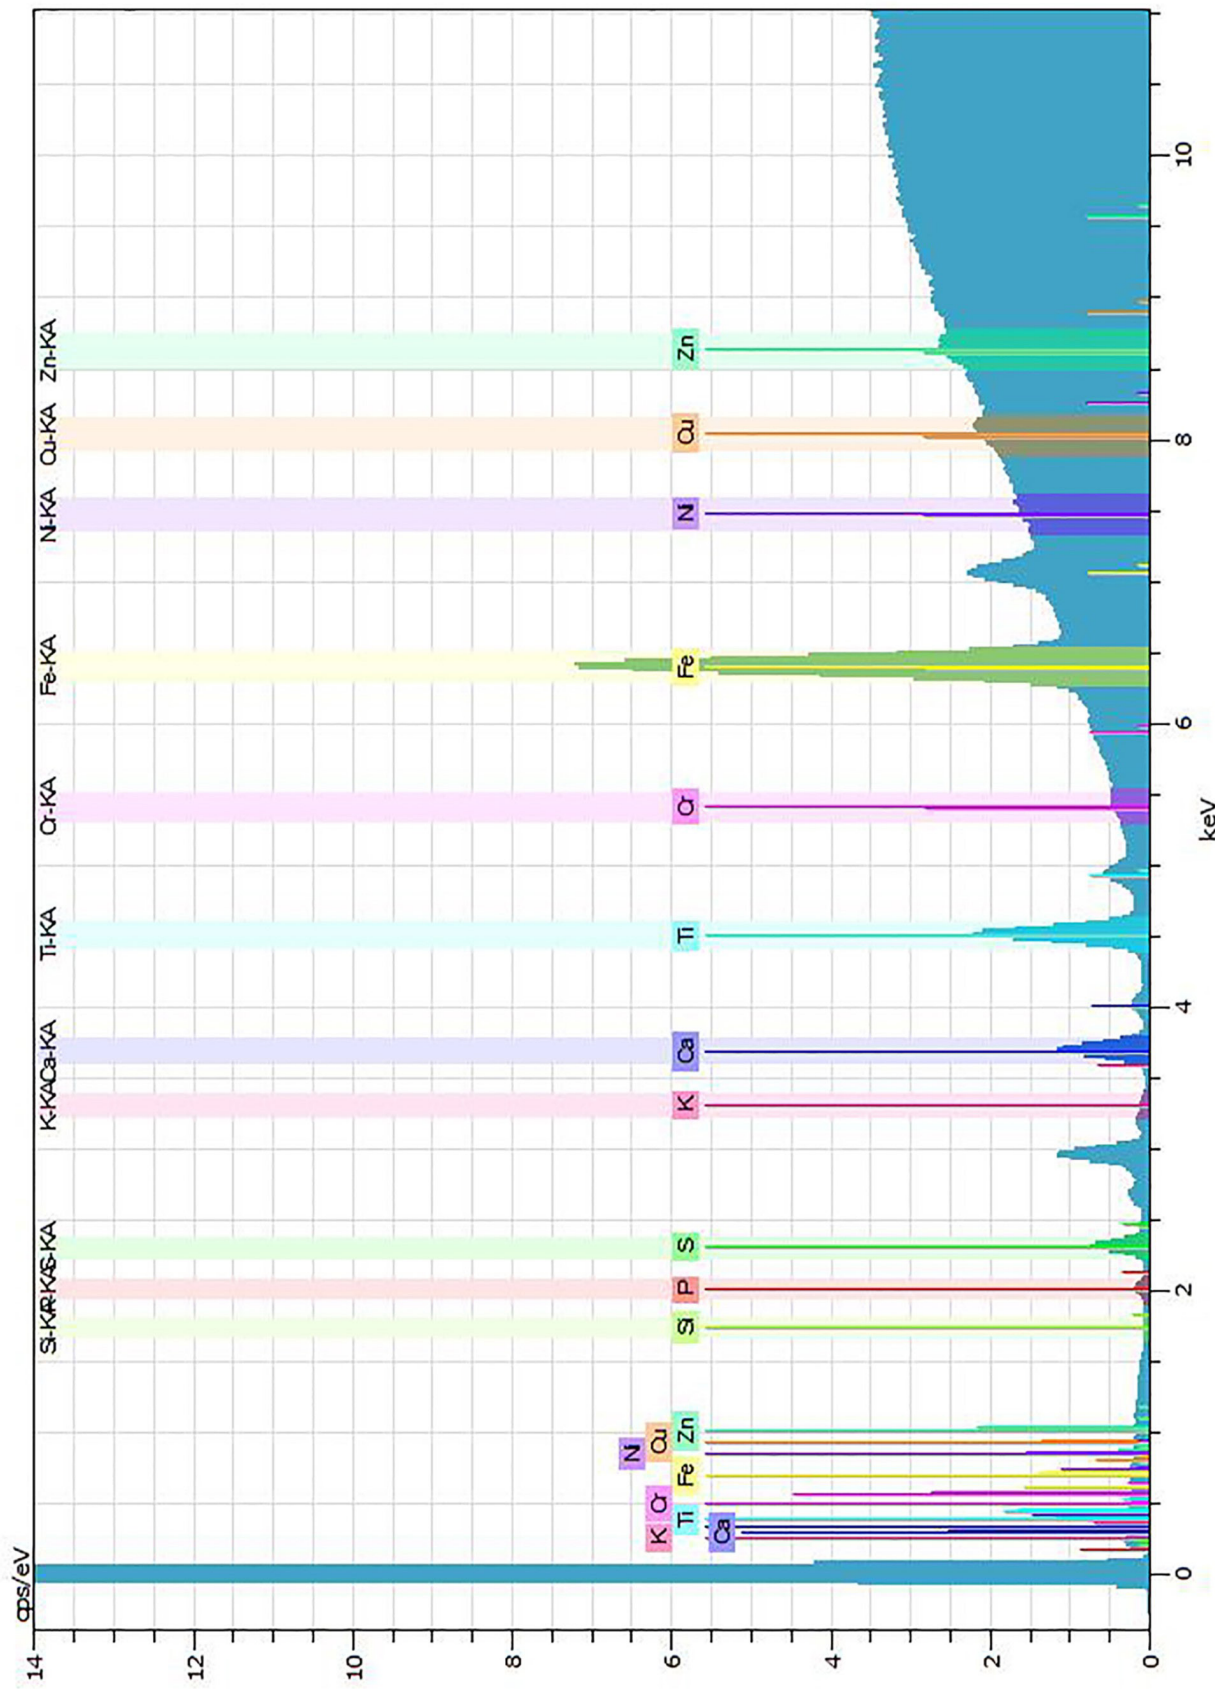
FIGURE 4. The obtained spectrum and concentration of chemical elements in the investigated areas (percentages by mass).
